Midwest Utility Case Study

VR2® Conductor Makes Installations Easy.

Project: New overhead transmission line in ice-prone region

Product Used: Southwire VR2® Vibration Resistant twisted pair design

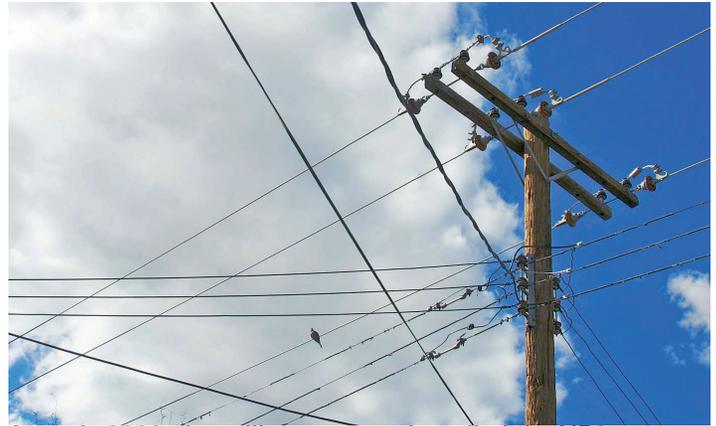
In early 2008, the utility company installed the VR2 conductors on a .65-mile stretch of 69 kV horizontal post insulator as a side-by-side comparison with traditionally-constructed twisted pair conductor on different phases of the three-phase line. VR2 cable is third from the left in the photo above. The traditional construction continued to exhibit bagging problems. The new VR2 went up without a hitch. "The difference was like night and day," says the project manager.

Even after the installation, the VR2 conductor difference is apparent. The foreman says, "With the old wire, even after we shake out the loops, you can drive down the road and see the irregularity in the twist of the conductor. The VR2 conductor is completely regular. This new wire is good stuff."
